Summarized Final Report

External Project Evaluation

**Soil and Water Conservation
in the Irob Woreda,
Tigray, Northern Ethiopia**

Zurich, 30th October 2003

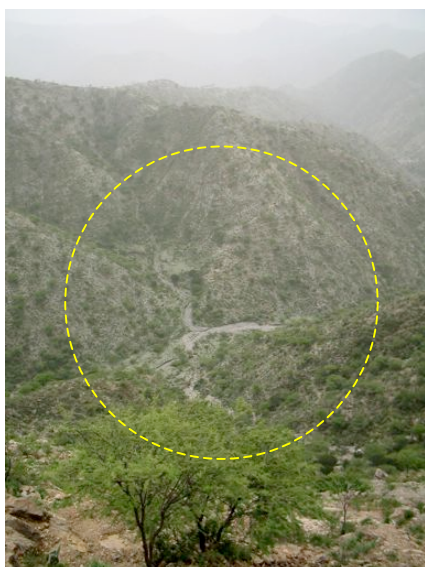
Illustration 1: The encircled zone indicates a potential area for the construction of check dams photo

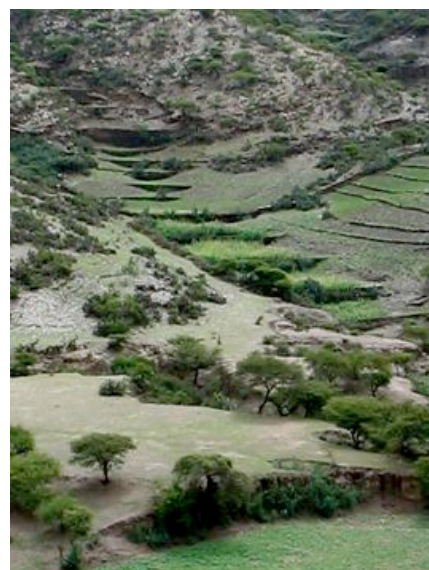
Illustration 2: Check dam sequence constructed by local farmers with cultivated maize fields in

Nowadays the “daldal” system is found all over the Irob Woreda. Beside the big check dams, built under ADDA, there are innumerable private check dams, which characterize the landscape of Irob (see illustration 2).

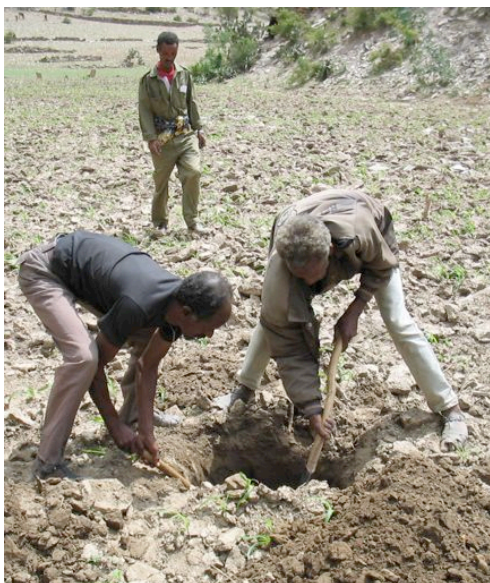
Illustration 4: Digging for the soil profile, always with the farmer's kind help, here in Dogogola, Upper Daya; July 2003.

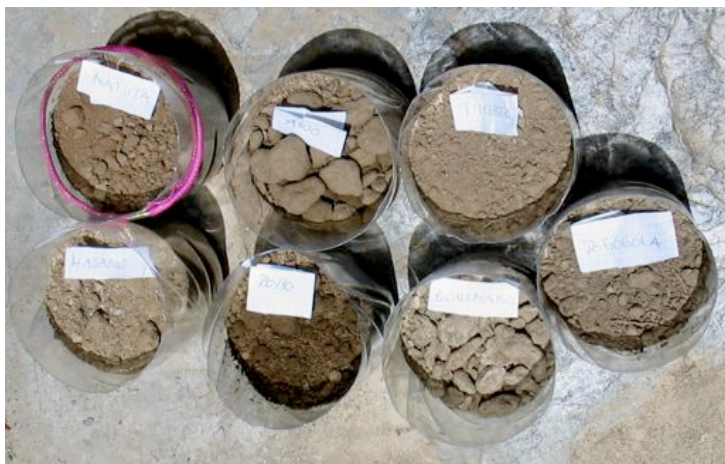
Illustration 5: Soil samples from the check dam fields; each container is filled up with 0.5 litre of soil; Alitena, August 2003

To get data about the soil's water absorption capacity, soil samples from the investigated fields were collected (see illustration 5). After letting them dry during at least 3 days, 0.5 litre of soil from each sample was irrigated with 0.5 litre of water. To avoid evaporation, the samples stayed covered during one day. The quantity of absorbed water was measured by the difference between 0.5 litres and the non-absorbed water which remained at the samples' surface.

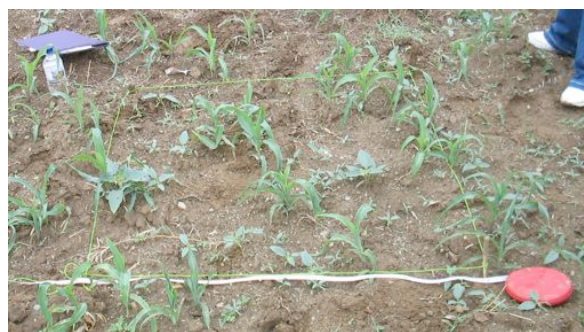
Illustration 6: Crop counting on Natiita's check dam Dasamo Gade, July 2003.

The counting of crops per square meter gave an impression about the check dam “productivity”. To get a representative area for the investigation of the crop quantity, the location was chosen according to the same criteria as for the digging of the soil profile. Afterwards the place of most crop density was selected. On every check dam, except the ones who were still under construction or without any cultivation, an area of 1 square meter was fenced off by a string as illustration 6 shows.

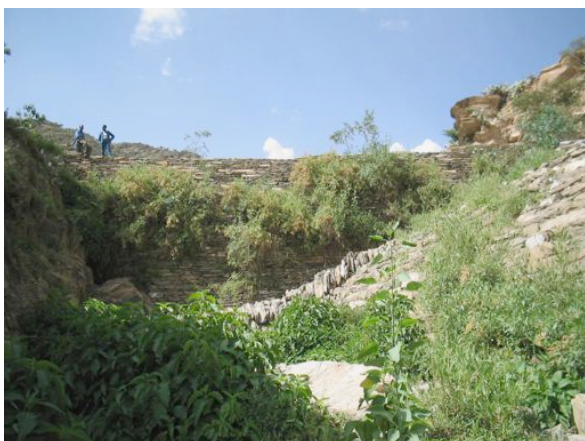
Illustration 7: Topmost check dam of the Dogogola sequence, with soil stabilizing stone embankment at the right side

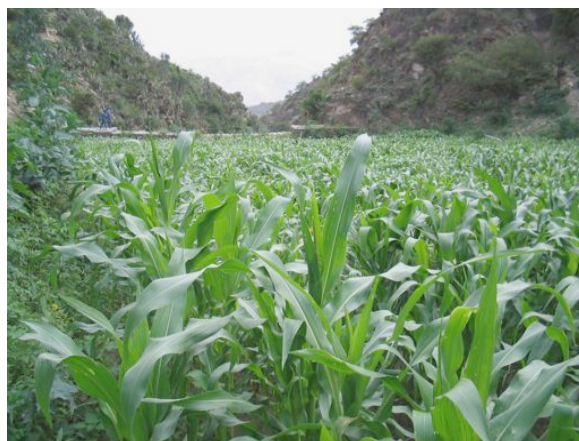
Illustration 8: Maize on the Dogogola check dam in September 2003 with an average height of 1.2 m.

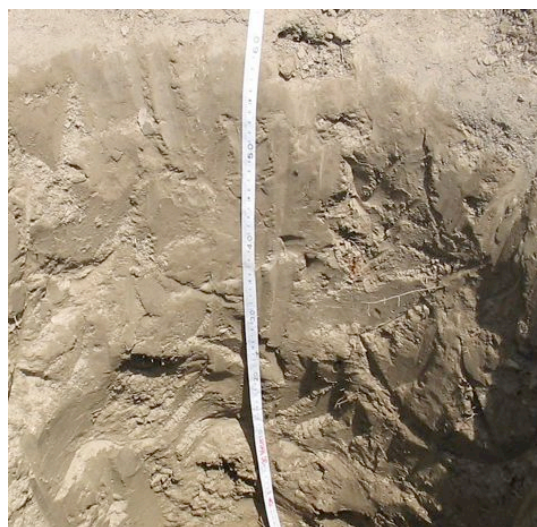
The profile (Illustration 9) of the ploughed soil reached a depth of about 65cm. The homogenous silt loam texture showed an increasing moistness until the bottom. The pH-value varied between 6 and 7. Tests with HCL shows occurrence of calc. Roots find their way until the holes' bottom. The soil volume of 0.5 litres absorbs 1.25 dl of water.

Illustration 9: homogenous silt loam texture in Dogogola, July 2003

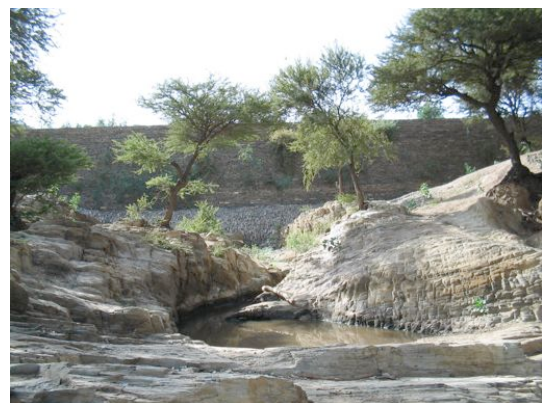
Illustration 10: Tikibta’s topmost check dam with part of its foundation; September 2003

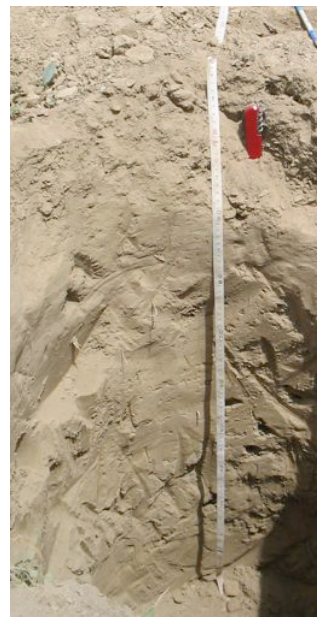
The soil profile of one metre's depth (Illustration 11) shows a homogenous clay loam texture. Although the same river irrigates the system, the soil is much dryer than in Dogogola. The matrix shows a finer structure and 0.5 litre of soil are absorbing 0.25 litre of water. Plant roots are reaching a depth of 80 cm. The pH-value of the calc containing soil was determined at the surface with 7.50 cm, deeper it was assessed between 7 and 8 and at the bottom a value of 8 was measured.

Illustration 11: Soil profile in Tikibta; July 2003

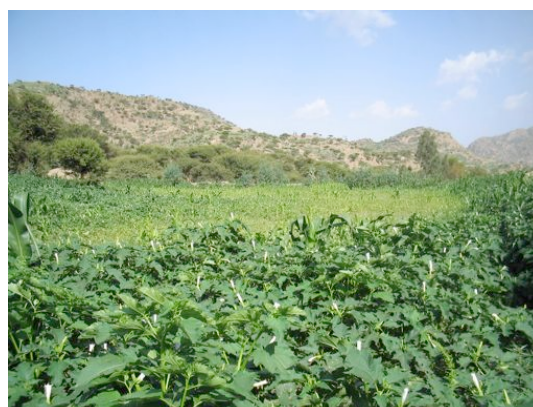
On the second visit of the field in September, the field was still not cultivated efficiently, only a plot of about nine square meters was covered with maize. The reason for this insufficient cultivation even after precipitations will be explained in chapter 4.3.2. paragraph 2 and 4.3.3. paragraph 3.

Illustration 12: Tikibta check dam field, covered with weeds (mostly *Datura stramonium*) in September 2003

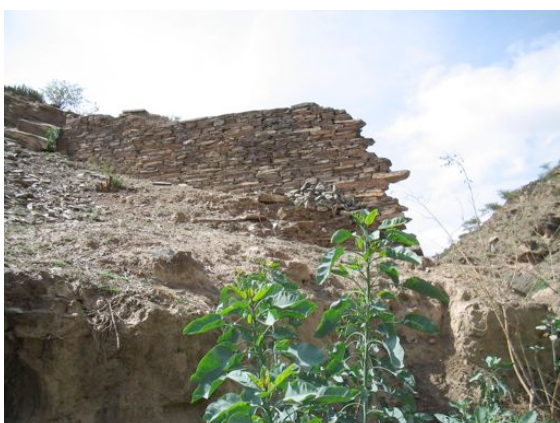
Illustration 13: Relics of the broken check dam;
T. L. 2002

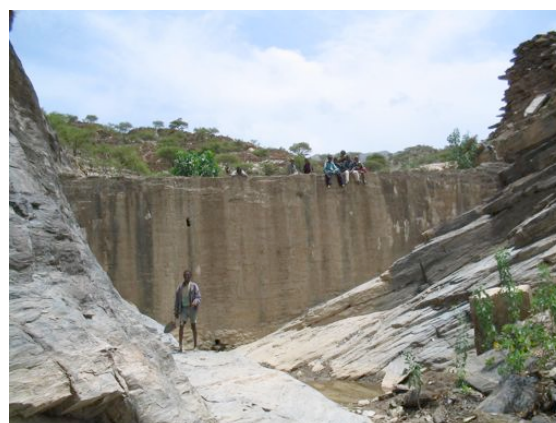
Illustration 14: Rebuilt cement check dam;
T. L. 2002

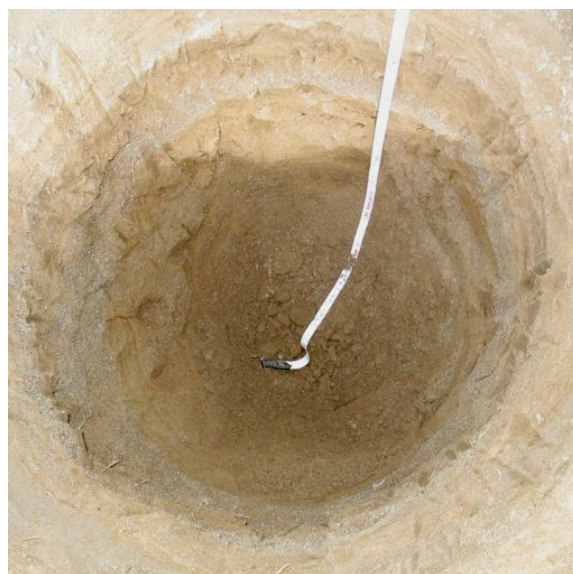
This unploughed check dam field shows an interesting soil profile with sequences of different sedimentation, as the sketch in illustration 16 demonstrates. Remarkable was a layer of silver shimmering light clay (illustration 17), only discovered on this check field. The soil density is very high except at the sandy part. Plant roots come through until a depth of 50 cm. Collecting in total 0.5 litre of the soil in a container, imitating the sequence of sediments, the sample absorbed 1.8 dl of water.

Illustration 15: Daamoita's soil profile from above; July 2003

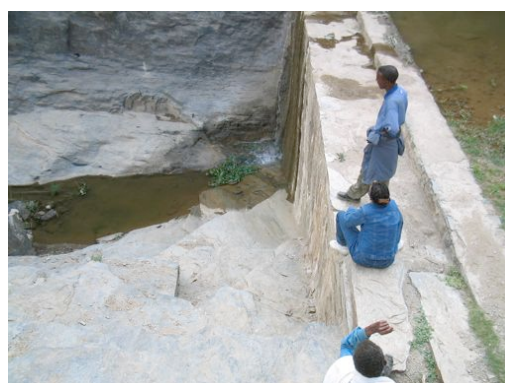
As already mentioned in the previous chapter, at the time of first survey puddles and pools could be found at the bottom of the check dam. During the second visit, the field was irrigated with water and a waterfall rushed down the dam. Before the construction of the check dam, the people could fetch water from the river only for 3 months. Since the building, there is enough water during 9 months in bad rain seasons

Illustration 18: Irrigated field and waterfall on Daamota's check dam in September 2003

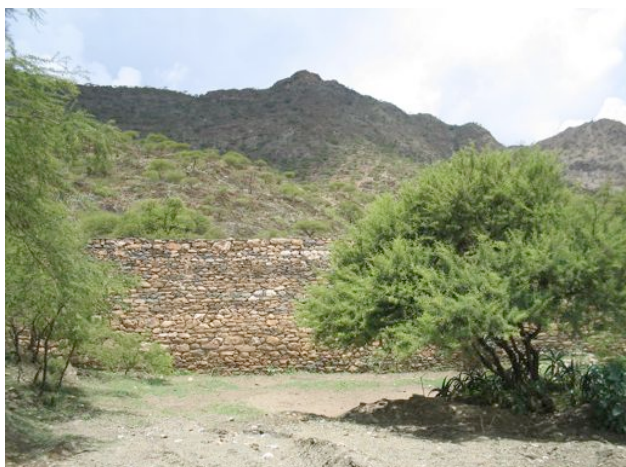
Dasamo Gade – Dawhan village / dry stone masonry check dam: 50m (24m) x 2.5m x 5m

Illustration 19: check dam of Dasamo Gade/Natiita in July 2003

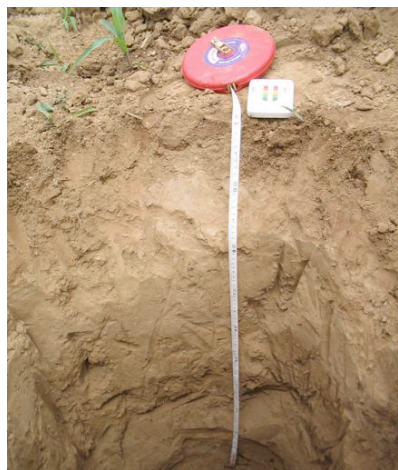
The one meter deep profile in the ploughed silt loam shows a homogenous fine structure (illustration 20). Plant roots reach till the bottom. Although rain fell the night before and in the morning of survey, the soil was surprisingly dry. The pH-value was continuously 7. A sample of 0.5 litre of soil absorbed 0.25 litre of water.

Illustration 20: Soil profile Dasamo Gade, July 2003

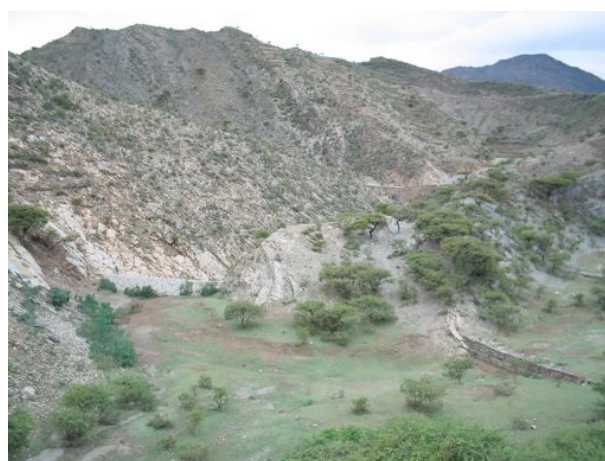
Illustration 22: Masanu check dam area (big check dam taking place at the bottom of the picture's left side)

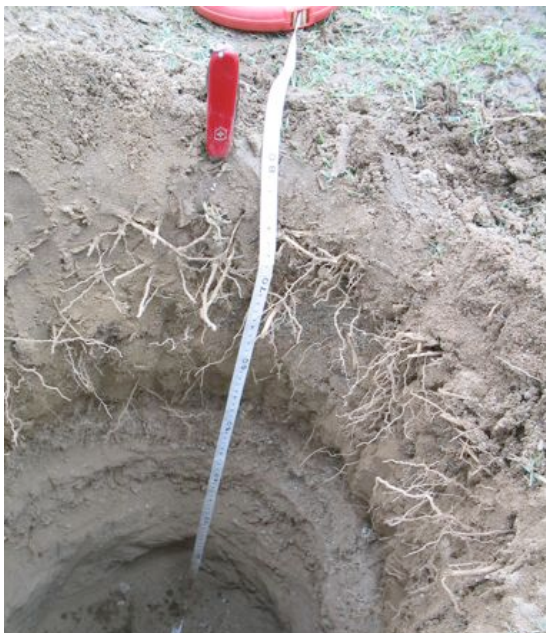
The unploughed soil was very hard and after a depth of 80 cm, we hit the rocky subsoil. As the following picture and sketch of the soil profile show, it contains several sedimentation levels in which the pH-value is varying. Imitating the sedimentation sequence in a container, half a litre of soil soaks up 1.25 dl of water.

Illustration 23: Sedimentation layer in Masanu;
July 2003

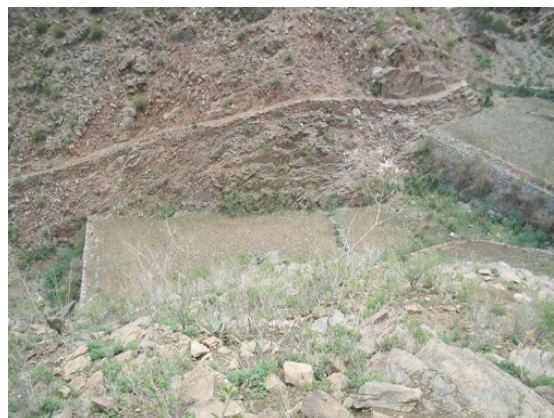
Illustration 25: Surveyed check dam and field in Bobo, July 2003

In Bobo, ADDA constructed a sequence of 15 check dams within a sub-catchment extension of about 20 ha. Since there were only two cultivated fields (on check dam 8 and 9), we investigated the 8th one, on which it was allowed to dig for the soil profile. The construction period lasted from March 1994 until December 1995. The workers were very active and wise in managing the project themselves and stone material could be found nearby the building site. The former owner of the land section between the 8th and 10th check dam, handed it over to the community, to make the check dam building possible. In return for his generosity, in some years he will be allowed to use the two reclaimed fields for his own (further information about check dam field ownership in chapter 4.3.2.). Beside ADDA’s check dams, the local people built their little private barriers on the slopes.

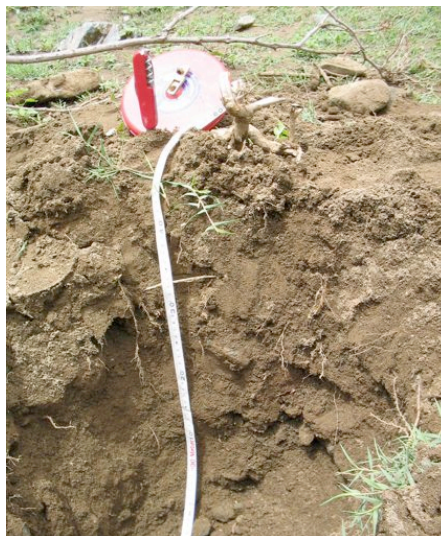
As the farmer did not allow to dig in the middle of his field, a soil profile beside the crops was surveyed. For this reason the soil quality was not very high and showed a loose texture of loamy sand, mixed up with rounded stones. At a depth of 50 cm we hit the hard subsoil and it was not possible to go deeper (see illustration 26). The pH-value was 6 at the surface and 8 at the bottom, containing few calc. During the water absorption experiment the matrix got compressed by soaking 0.7 dl of the added liquid.

Illustration 26: Soil profile beside the Intigade check dam field; July 2003

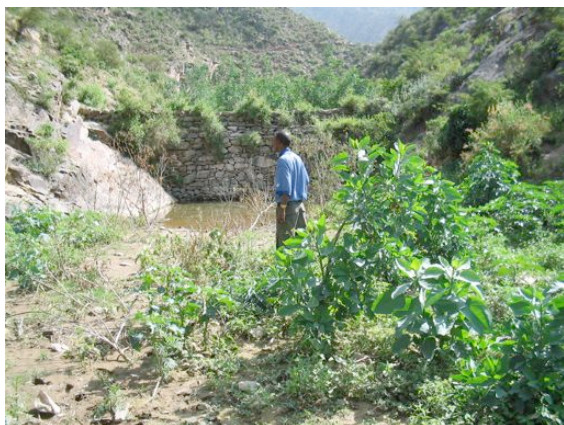
Following the sequence uphill during the second visit in September, the first three fields were filled up with water. Crop cultivation seems not possible but the fields show high quantity of animal food (see illustration 27). In the upper part of the sequence, the power of the flood may be too high for weak cereals. But especially the 7th showed good conditions to be cultivated (see illustration 28). Since the cultivation of wheat in the middle part of the sequence was possible, a failed organization between the 15 farmers may have impacted the field cultivation. For further statements and conclusions see as well chapter 4.3.2.

Illustration 27: 2nd Intigade check dam field with obviously bad conditions for crop cultivating in September 2003

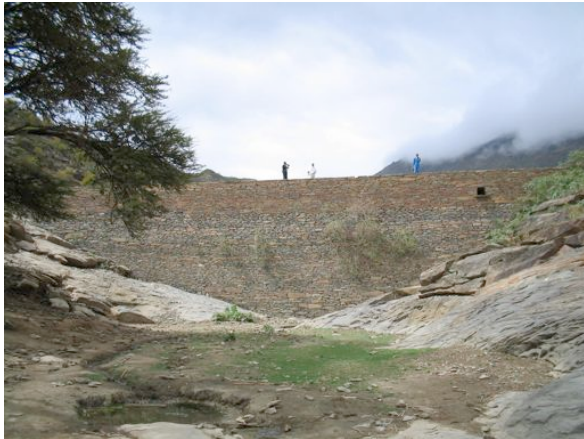
The interesting site in Awo is flooded by two rivers, lying in a sub-catchment of about 40 ha. Within the sequence of 10 check dams, we investigated the first and biggest one. It was constructed in 1976 and extended from April 1986 until July 1987. During its construction, an old man passed by the building site saying: “You are crazy to build a barrier here! It will break because here passes the way of god!”. But up to now, the check dam stood the flood firm.

Illustration 29: Front view of the Alakalo check dam; July 2003

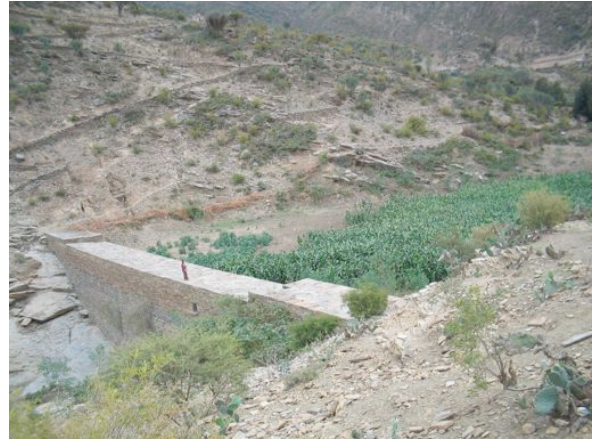
Illustration 30: Alakalo check dam with maize crops promising rich harvest, July 2003

Regular periods of stagnant water within the layer of plant roots can hinder or slow down the growth of the crops. An indication for this process could be the uncovered plot in the field, obvious in illustration N° 30.

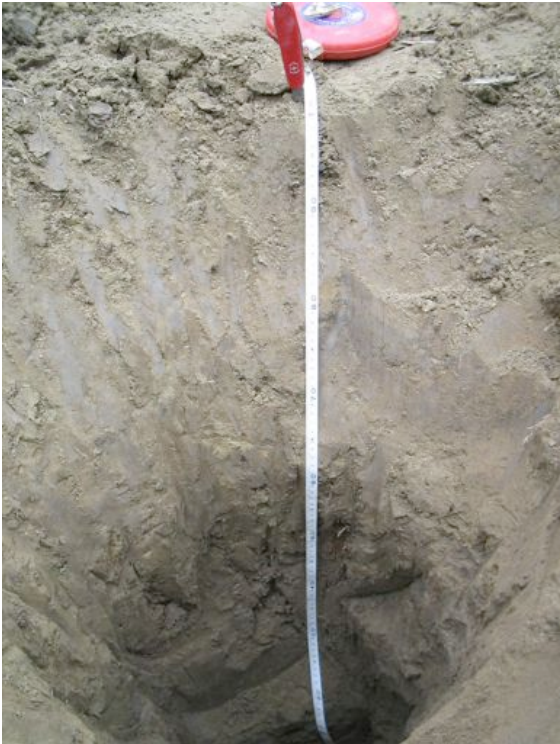
The 1 m deep soil profile within the ploughed field had a light clay texture. Plant roots reached till the ground. The soil was very moist and dense. Half a litre of soil example absorbed 1.24 dl of water. The pH-value varied from 7 at the bottom until 7 - 8 at the surface and experiments with hydrochloric solution detected few calc. Over the upper 50 cm of the profile, black spots were distributed. In combination with the high moistness and soil density, indicating a low aeration of the soil, they are obviously the result of chemical reduction of manganese. Other signals for the lack of oxygen were found mainly within a layer at 60 - 80 cm depth. The soil was drawn through with thin channels having diameters of needles, framed by red coloured soil. This is apparently the matter of iron, shifted from the pores to the matrix, converted into iron-oxide.

Illustration 31: Soil profile of Alakalo; July 2003

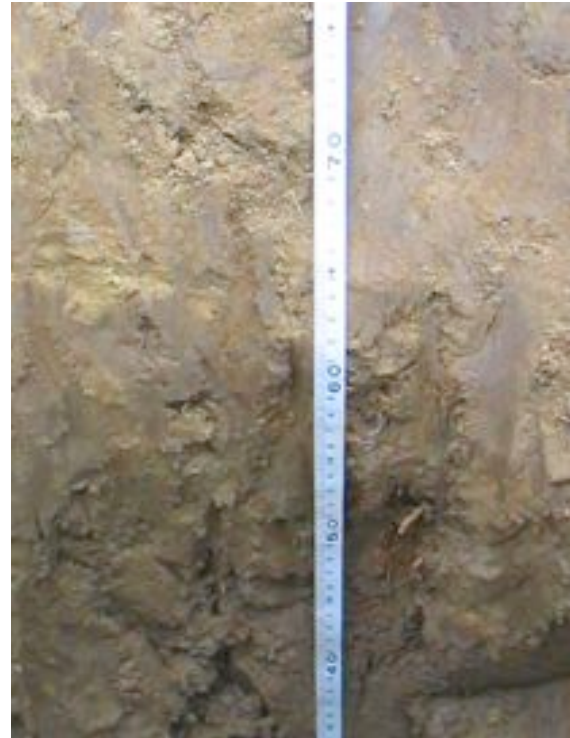
Both phenomena are often found in soils with alternating conditions of built up water and soil aeration. In the with water saturated pores, the Fe^{3+} and Mn^{3+} ions are reduced to the water transportable forms of Fe^{2+} and Mn^{2+} . The shift takes part firstly along the gross soil pores and root channels and is later spread to the fine matrix. In the following, when the soil became aired during the dry season, the elements get oxidised to Fe^{3+} and Mn^{3+} again with resulting rusty traces and black spots, characterizing the fine soil.

Illustration 32: Detail of the soil profile, showing black and red coloured traces, results of chemical reduction-oxidation processes; July 2003

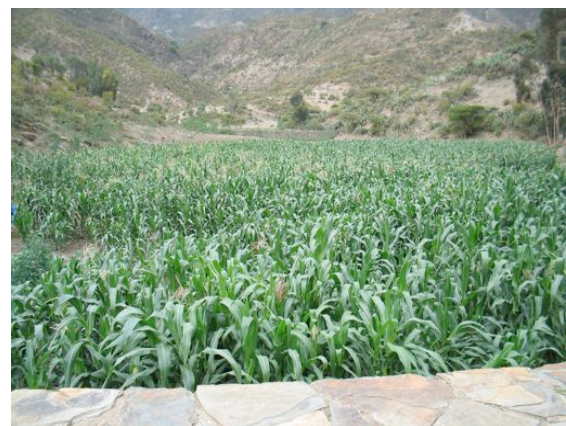
Illustration 33: Maize in Alakalo; July 2003

Despite of the described soil processes, the round 3'500 m² large field is cultivated with high maize crops with an average height of 2m (illustration 33). The other check dam fields could not be cultivated because of the damaging flood in the upper part of the river system.

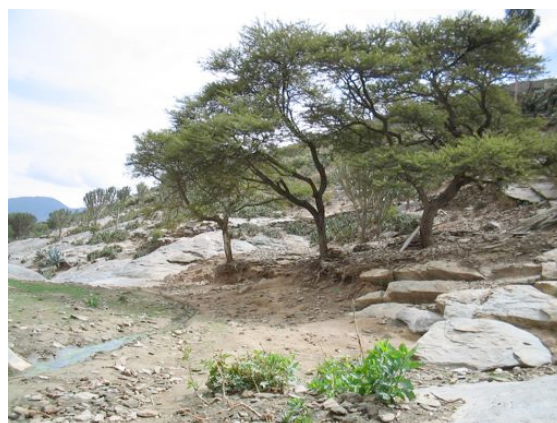
Illustration 34: Growing acacia trees after the check dam; July 2003

After the check dam, trees, bushes and herbs cover the area (illustration 34). Farmers reported that the plants were not growing until the check dam had been built. These plants are used as animal food, medicine (Aloe and “udgahara”) as well as for cooking (“hamla”). Birds find there their habitat as well as in the maize field. Increasing populations of porcupines, ground-squirrels and monkeys were reported and in some seasons “remmita” worms damage the harvest.

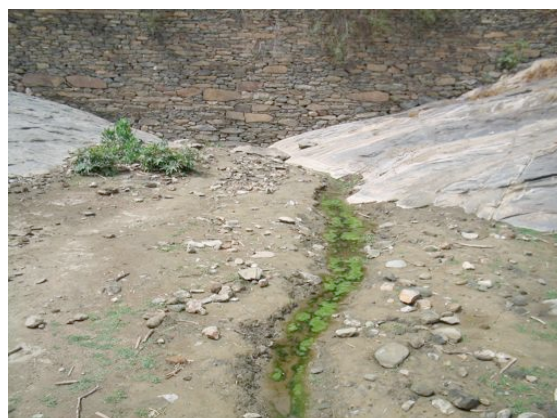
At the bottom of the check dam a beautiful spring flows (illustration 35). The water of good quality is used for drinking. It is running during the whole year, in good and in bad rain seasons.

Illustration 35: spring at the check dam's bottom; July 2003

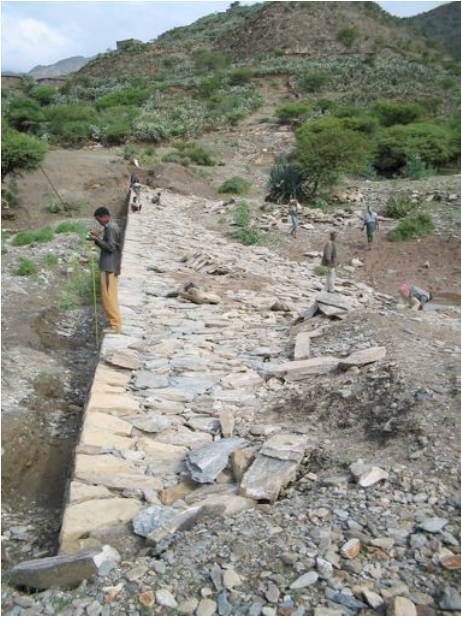
Illustration 36: Working on the check dam of Belguba in August 2003

The check dam was visited on the last day of its construction, which started in February 2003. As the building material was not available near the site, people carried the stones over a distance of approximately 1 km. The field will be silted up by the “Gaugau” river, since the check dam lies between Dogogola and Tikibta. The collecting sub-catchment measures approximately 10 ha.

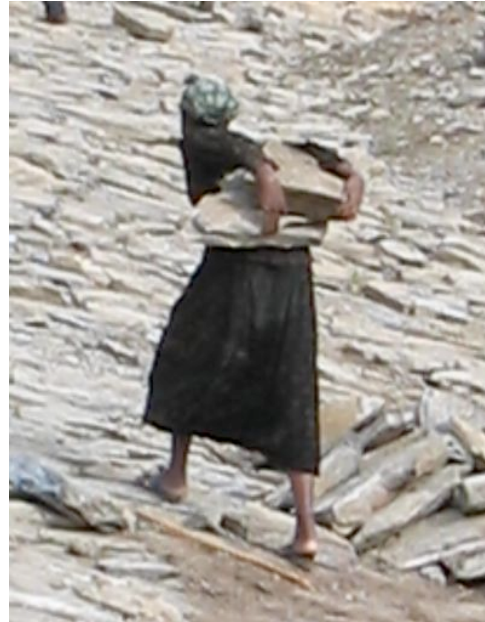
Illustration 37: Woman carrying stones to the Belguba building site; August 2003

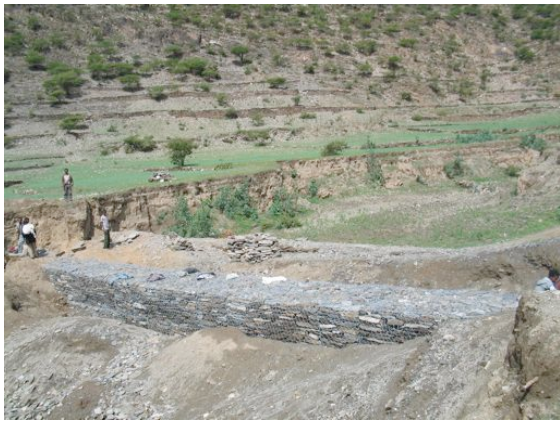
The sequence of three little gabion check dams was built for gully reclamation. The first one was under construction since Mai 2003 to get finished at the day of visit. For its building it was very difficult to find good stone material, at the end it had to be brought over several kilometres distance to the building site. As the gully has an average height of about 6 m, in a first step the 3 m high gabion dam has to be silted up and stabilized, before it can be made higher.

Illustration 38: Gully reclamation by a gabion check dam; August 2003

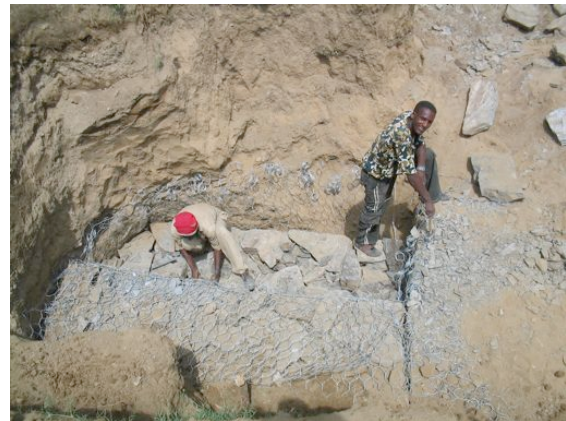
Illustration 39: Filling up the gabion with stones; August 2003

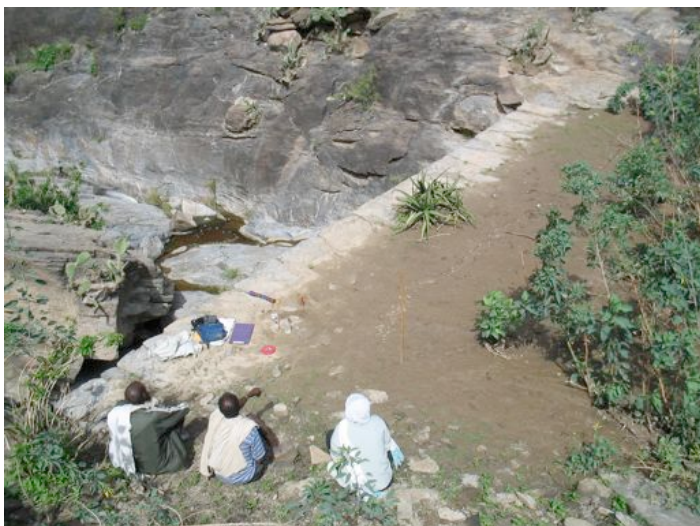
This sequence of 4 check dams is the topmost within the “Gaugau” river system from which the first was selected. When the construction started in March 1994, a good rock foundation was found. No extra excavation was needed, saving a lot of costs. The building could be completed three months later. The check dam’s special characteristics are described in the following.

Illustration 40: Up view on the Ubuktole Ela check dam, showing the running brook coming out of the check dam’s bottom; August 2003

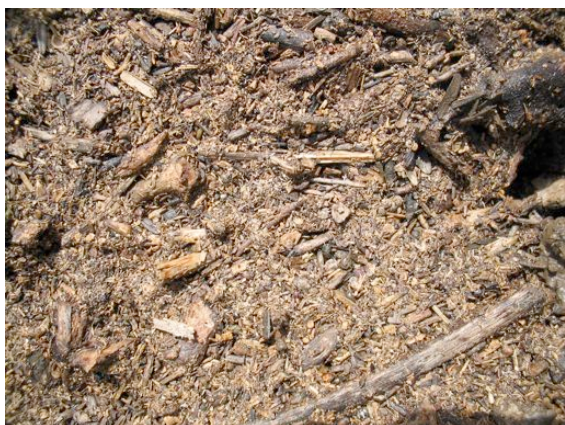
The check dam field of about 340 m² can be divided into two parts: Within a streak along the wall, app. 2.5 m broad, the soil has a silt loam structure. The other part is silted up with a lot of chopped up organic material (see illustration 41), totally saturated with water. Digging for a soil profile in this site was not possible since it was too swampy. Footprints were filled up with water very fast and the farmers warned us to enter the field. Nevertheless the pH-value was measured right under the surface and determined with 7 – 8 within the marsh and 8 on the calcareous silt loam. Under the layer of plant rests, with a thickness of about 20cm, the soil matrix gets mixed up with loamy sand. The water absorption experiment could not be done, since there was not enough time left in Alitena, to let the samples dry.

Illustration 41: Close look on the organic material from about 0.5 – 1cm length in average, covering app. 2/3 of the swampy check dam field in August 2003

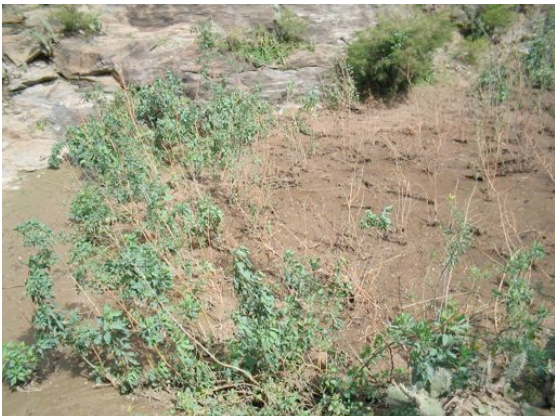
Illustration 42: vegetation of the swampy field;
August 2003

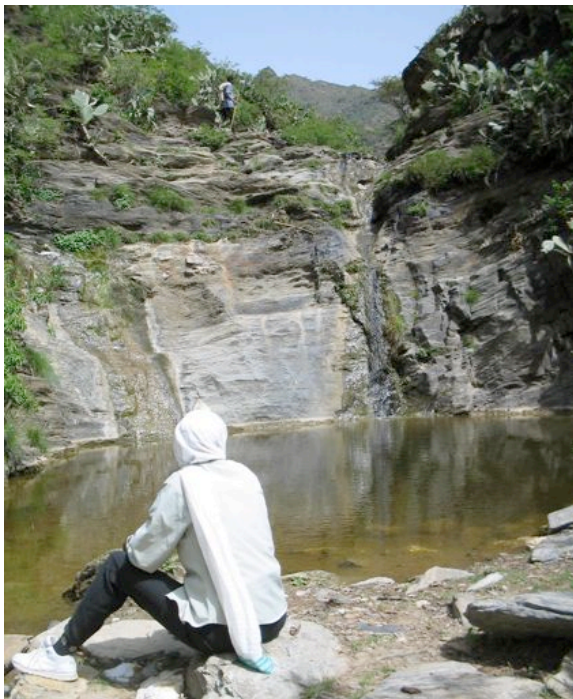
Illustration 43:

Following the check dam uphill, the proof for an effective water conservation due to the check dam system is found. Between the second and the third check dam a little paradise was discovered, where a small waterfall rushes into a pool; August 2003

As already described and illustrated in the chapters before, the check dams are conserving the water really good and provide the site with plenty of running water, where before only dry rocks could be found. Now along the whole sequence, a brook is rushing down the river bed, collected in many puddles and pools, reaching finally the area beyond the lowest dam. In the upper part of the check dam, water can be fetched all over the year, while the spring at the lowest check dam is running for 12 months in a good year and for 3 months in bad rain seasons. The farmers judged the water to be of very high quality and compared it even with the “Highland mineral water”.
